SIDE - TONE MODIFICATION

(Circuit Board 1092-3, SPA-400 Panel Mount, S/N 60975-61959)

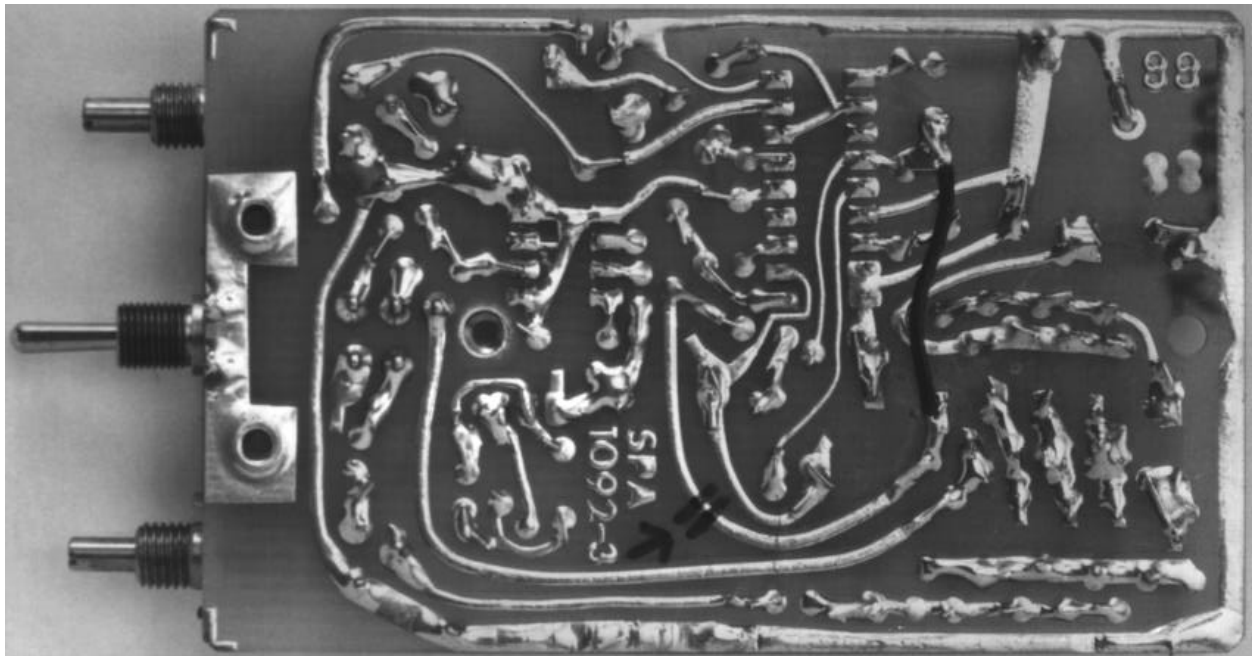
Most aircraft radios have side-tones; however, it has been noted that some of the Cessna 300 and 400 series, as well as some other radios, do not. Without side-tone, you will not hear yourself or your co-pilot transmit to ATC. If the Transcom is used for instruction and/or you wish to hear the transmissions, a simple modification can be performed within the unit to simulate side-tone. This is accomplished by separating the etch where indicated and installing a jumper as illustrated.

The SPA-400 required partial disassembly to accomplish the side-tone modification. To disassemble unit, carefully remove the screws securing the cover; back each screw out evenly to prevent the cover from bending.
